U.S. ENVIRONMENTAL PROTECTION AGENCY - REGION 6
FINDINGS OF VIOLATION, COMPLIANCE ORDER, AND INFORMATION DEMAND
In the Matter of Creed Operating Company, LLC (Respondent)
Docket No. CWA-06-2013-1724

INSPECTION REPORT

Creed Operating Facility Co., LLC

Subject: Novice Unit Lease RRC 10904 Discharges to tributary and Jim Ned Creek (Point of Entries)

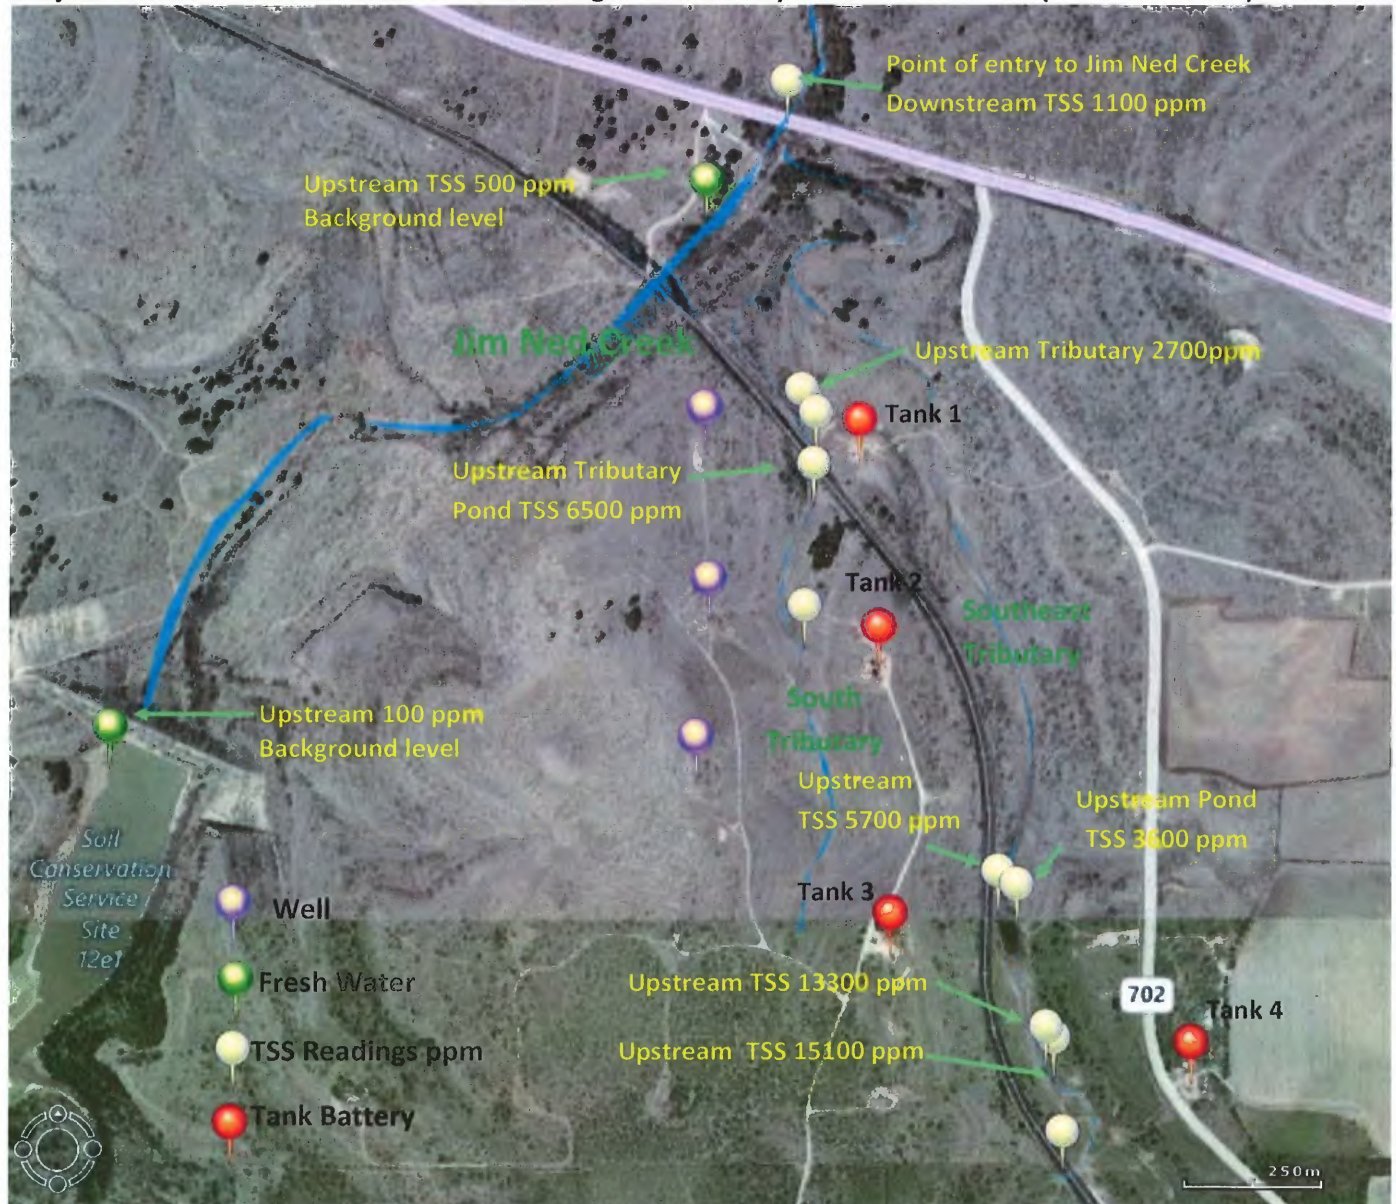
Aerial photo of Creed Operating facility showing brine discharges to tributaries and Jim Ned Creek. Facility needs to take appropriate actions to remediate the affected areas to background levels. Remove all brine from the flow path located in between the facility and the identified S and SE tributaries of Jim Ned Creek.

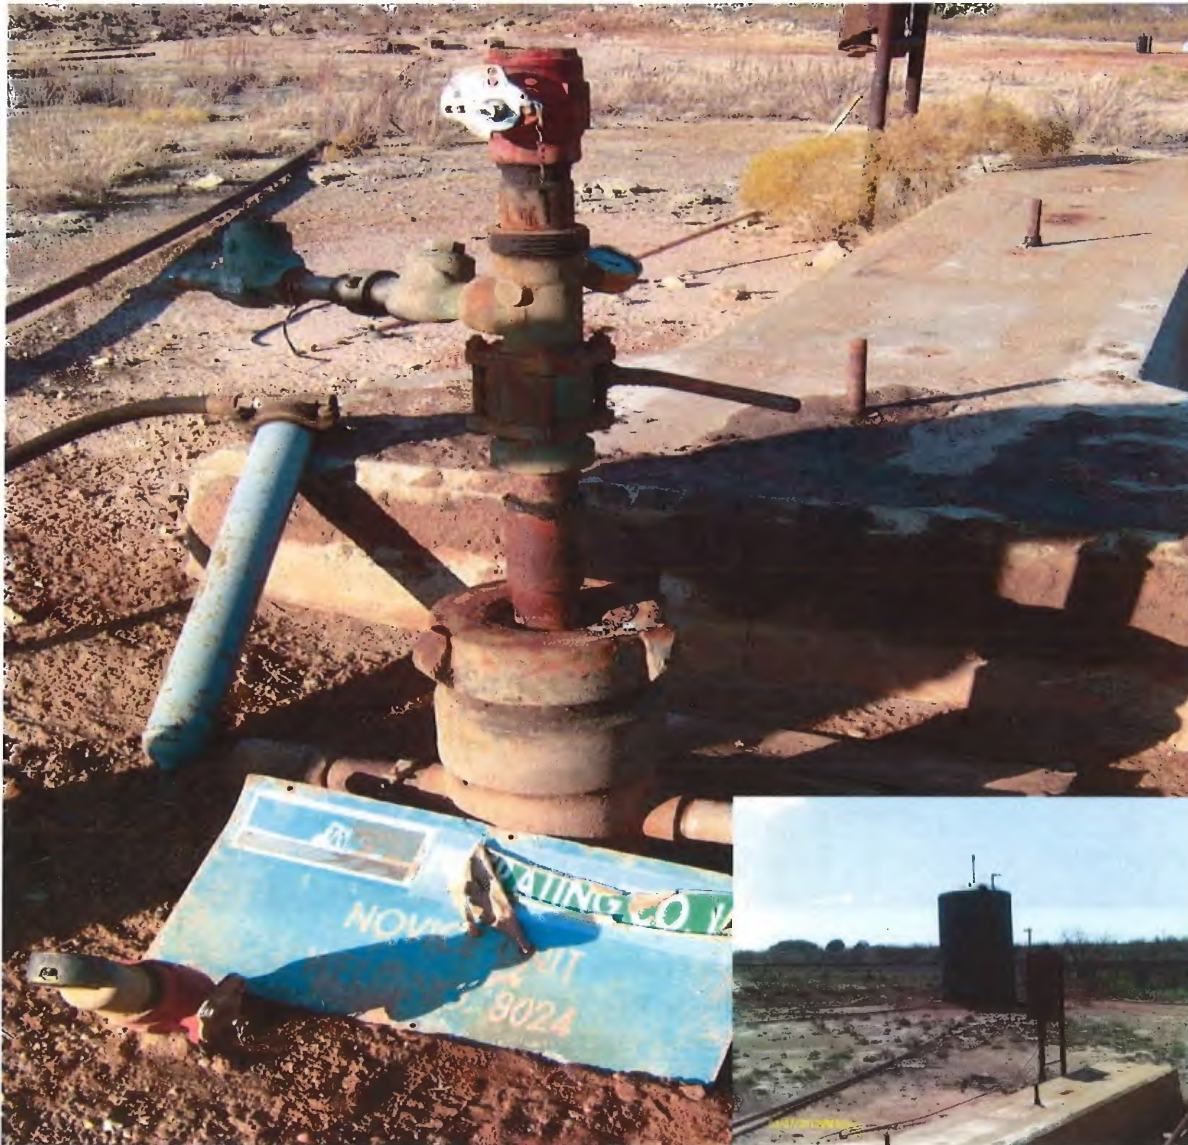
Creed Operating Facility Co., LLC Photo 1

Photo #1. Facing south from point of entry to Need Creek. Observed an injection well and abandoned storage tanks parts. Apparently tank was removed, but not clean up was completed. Observed a discharge flow path going towards to tributary and eventually to Ned Creek.

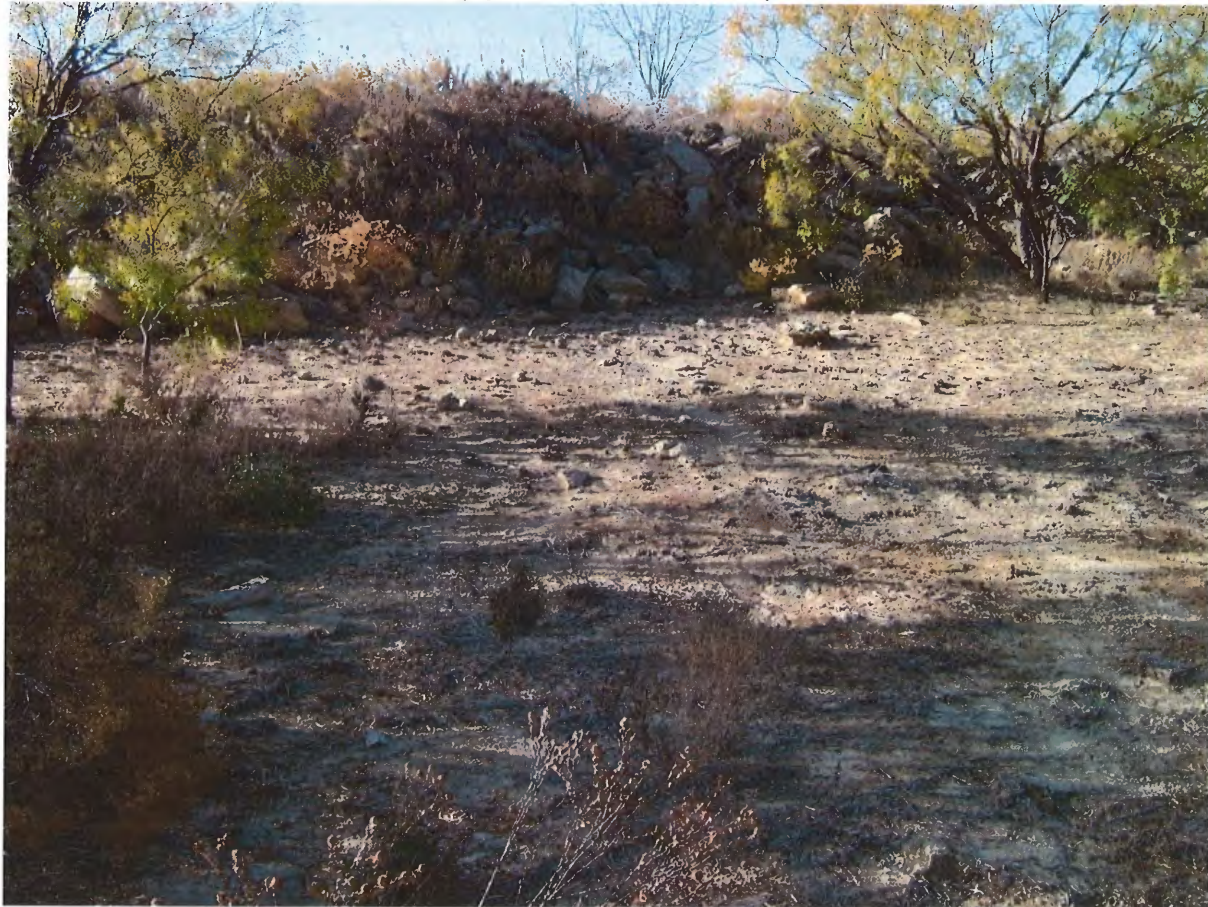
Creed Operating Facility Co., LLC Photo 2

<p>Photo #2. . Facing south east from point of entry to Need Creek. Observed a flow path coming from the injection and tank site. Discharge flow got into the tributary and eventually to Ned Creek. Observed salt crystal on soil and dead vegetation along the path.</p>

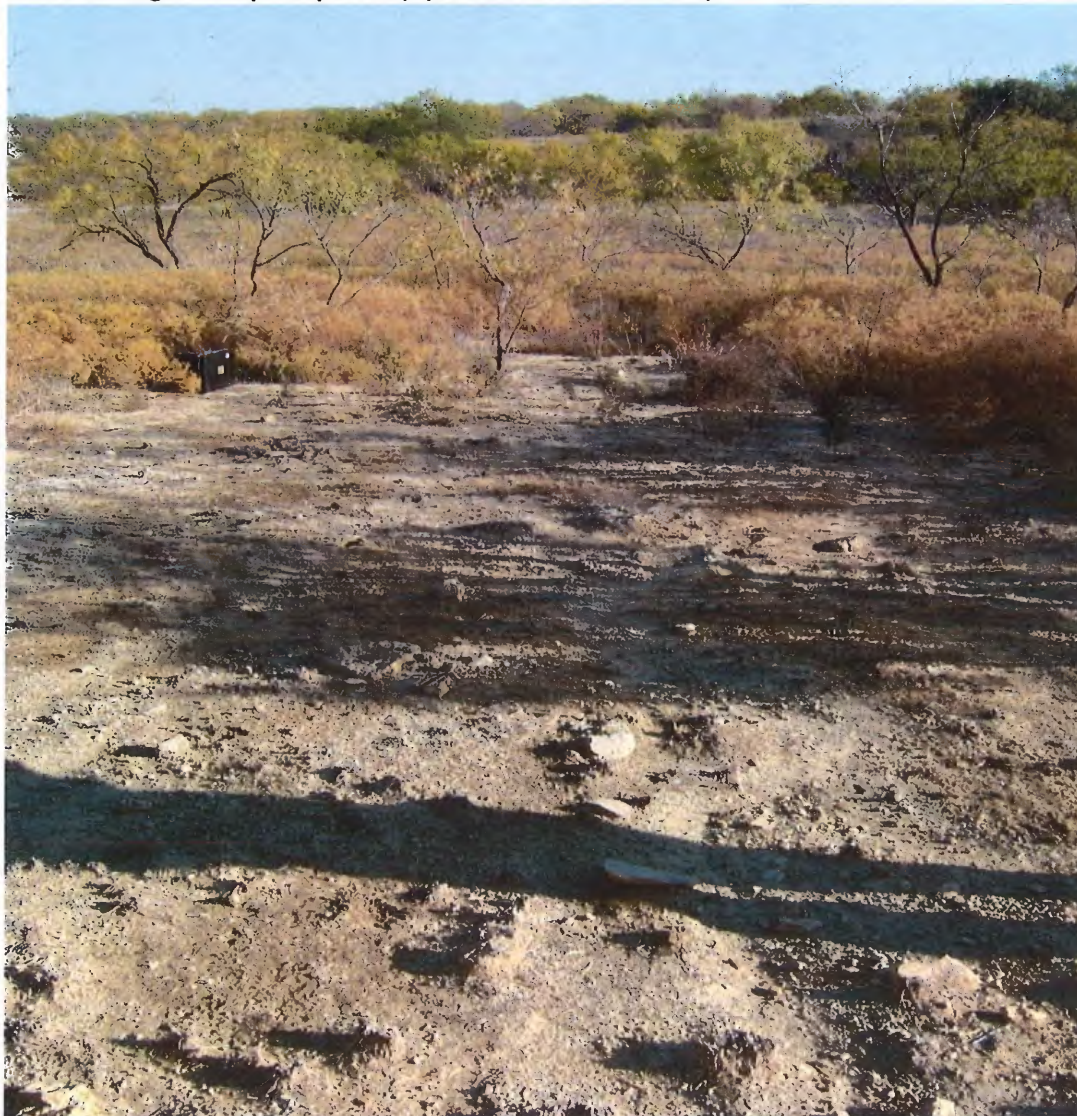
Creed Operating Facility Co., LLC Photo 3

Photo #2. . Facing south east from point of entry to Need Creek. Observed salt crystals on soil and dead vegetation along the path. Discharge went from tributary to Ned creek.

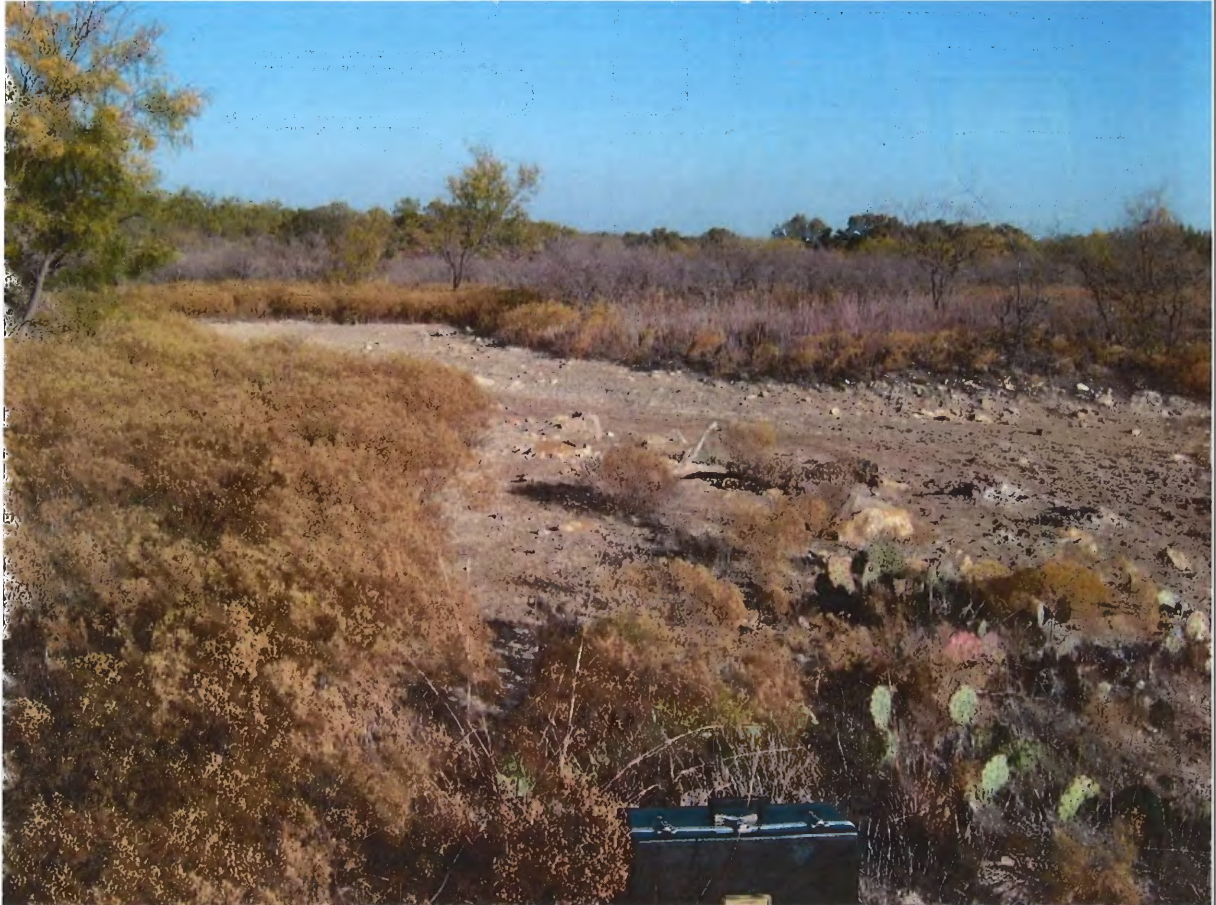
Creed Operating Facility Co., LLC Photo 5

Photo #2. . Facing south east from point of entry to Need Creek. Flow path linking to tributary and eventually to Ned Creek.

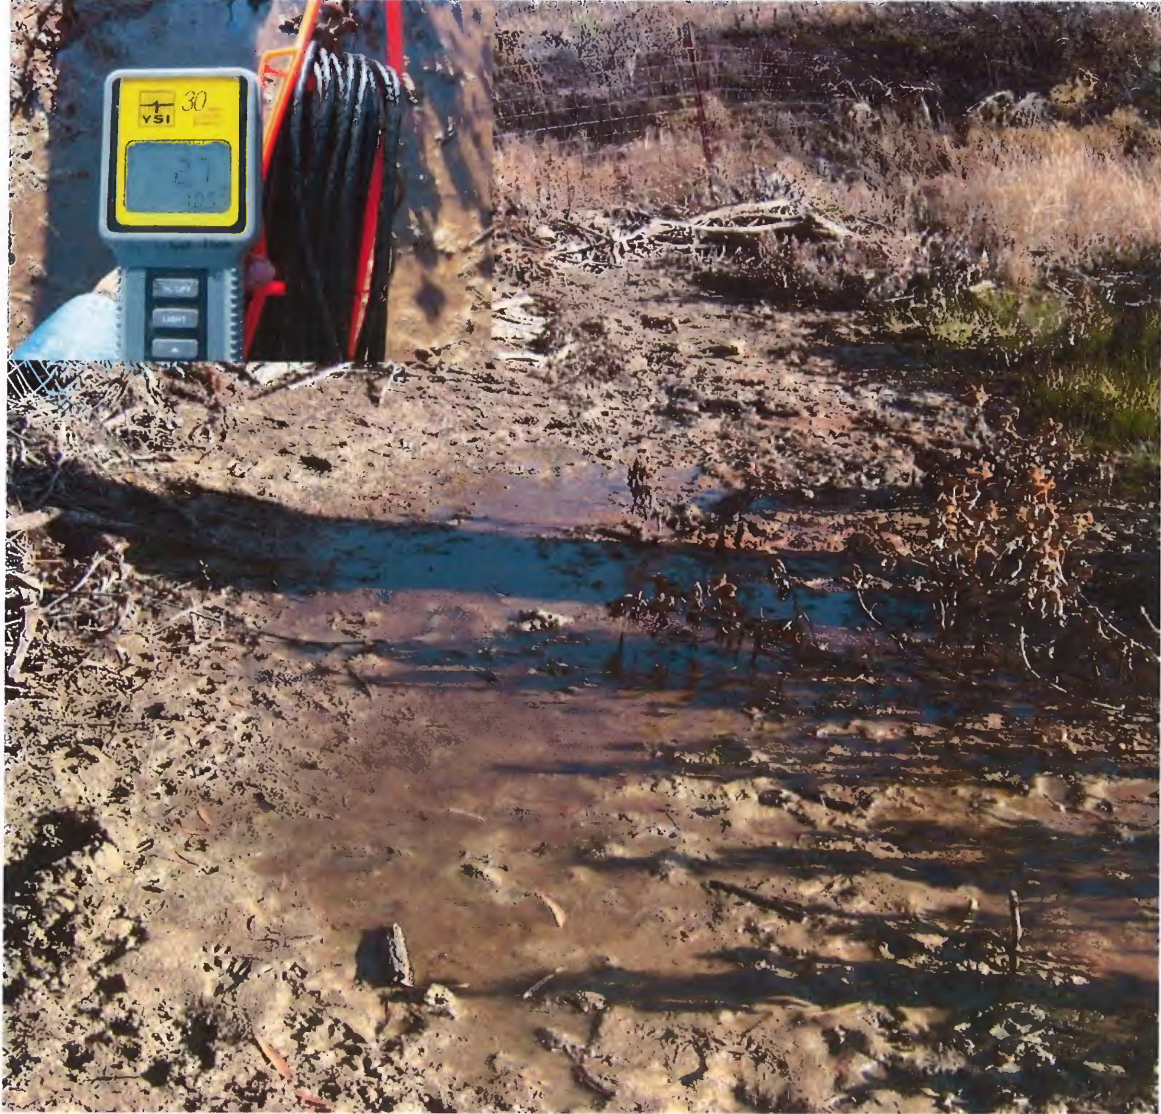
Creed Operating Facility Co., LLC Photo 6

Photo #6. Facing south east from point of entry to Need Creek. TSS measurement of standing fluids was 2700 ppm TSS. Observed shiny oil sheens, some oil residues, and small formations of salt crystals.

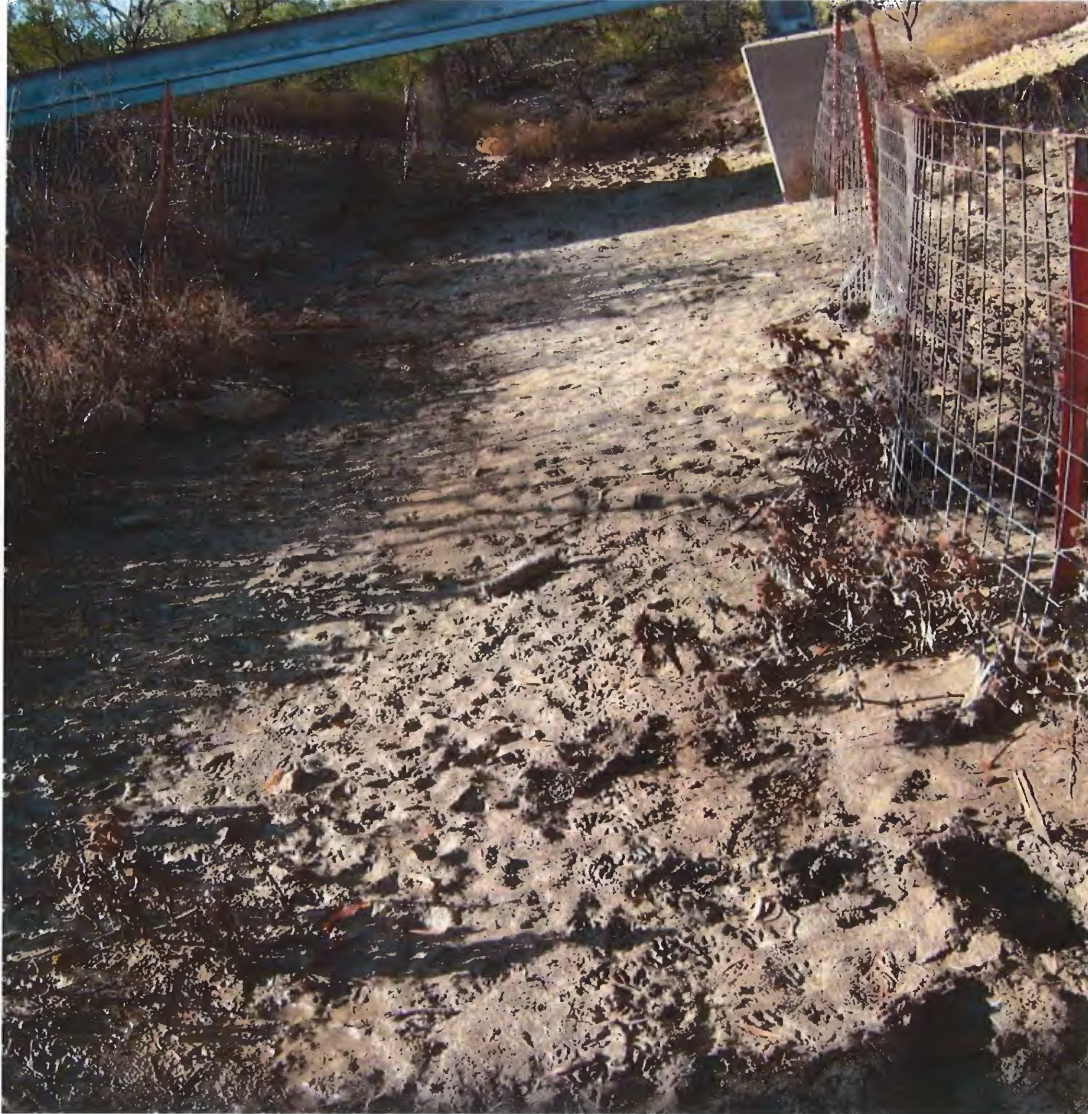
Creed Operating Facility Co., LLC Photo 7

Photo #7. . Facing south east from point of entry to Need Creek. Observed small formations of salt crystals, flow paths of discharges, and flow paths were connected to a pond (north of flow path) that was contaminated with produce water (6500 ppm).

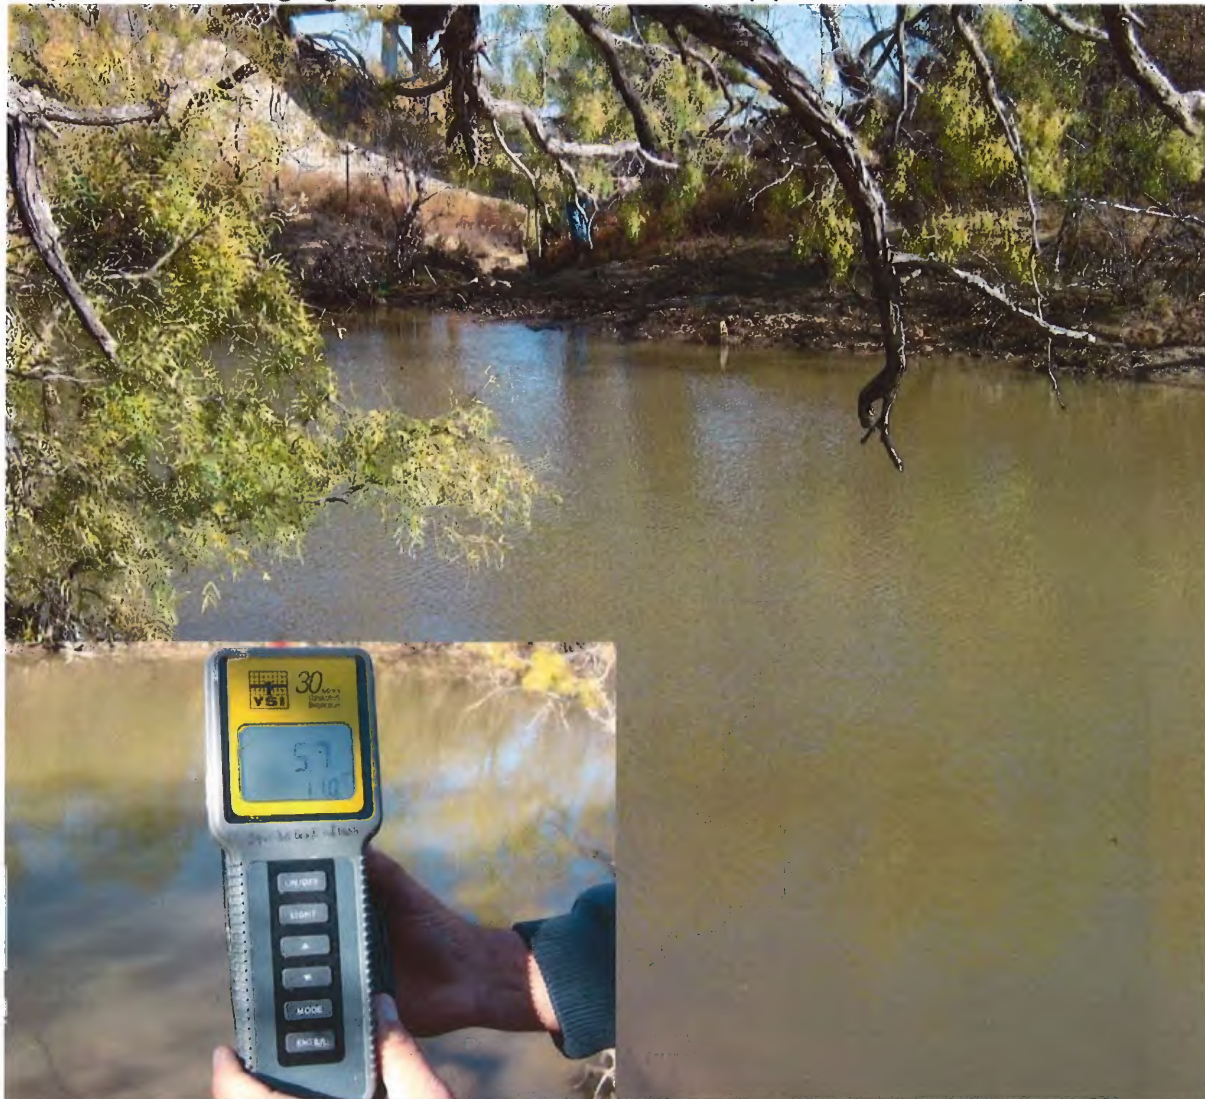
Creed Operating Facility Co., LLC Photo 8

Photo #8. Facing south east from point of entry to Need Creek. TSS measurement of standing fluids was 5700 ppm TSS. Did not observe microorganism in pond water. Pond is connected to the tributary upstream and downstream.

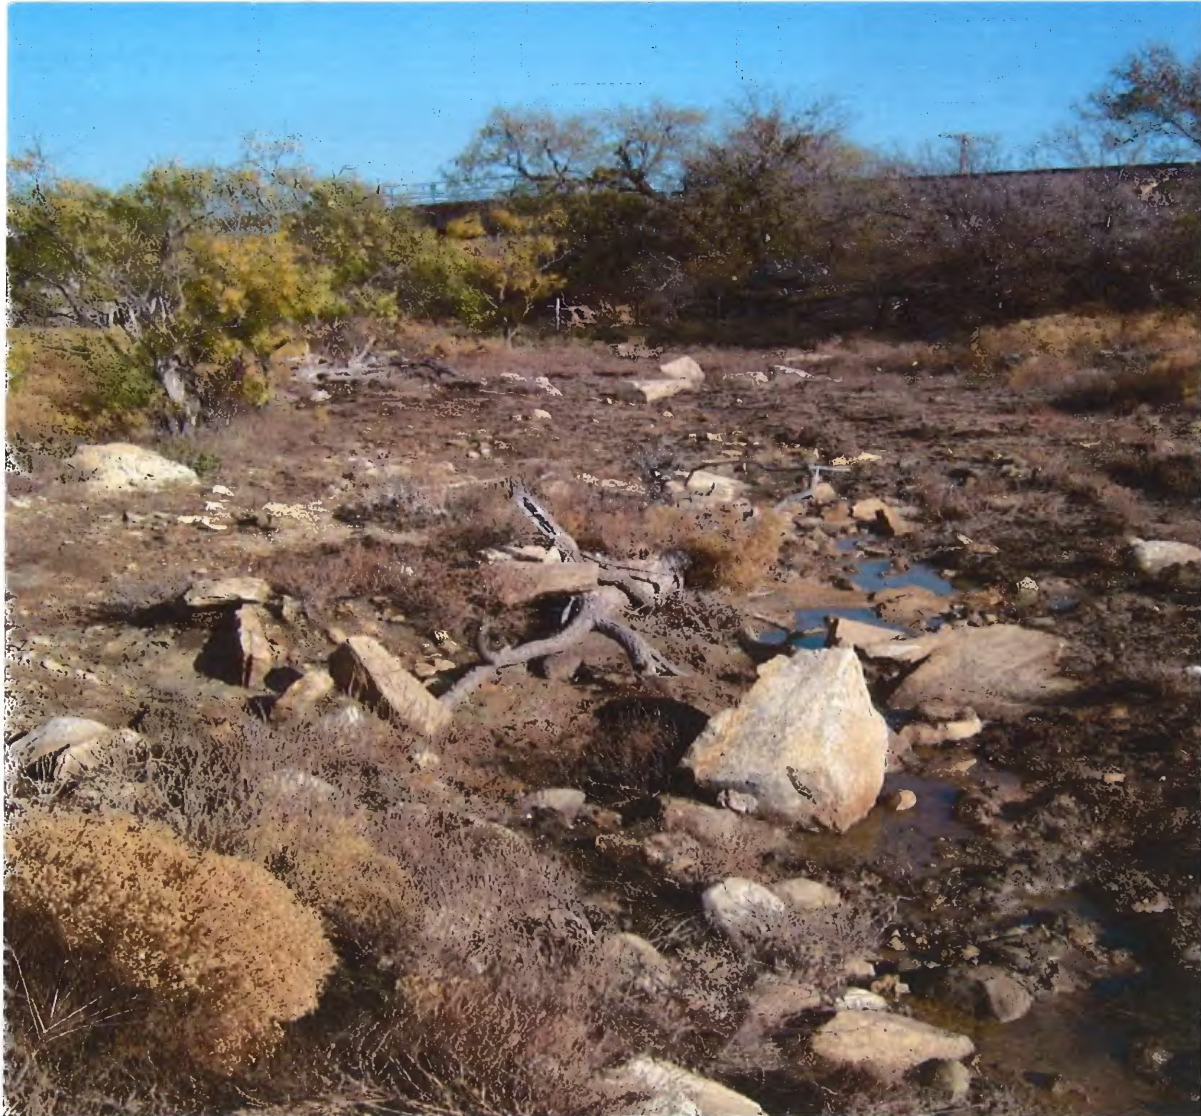
Creed Operating Facility Co., LLC Photo 9

Photo #9 . Facing south east from point of entry to Need Creek. Observed a tributary upstream to the pond containing produce water (salt water). TSS concentration was 6500 ppm.

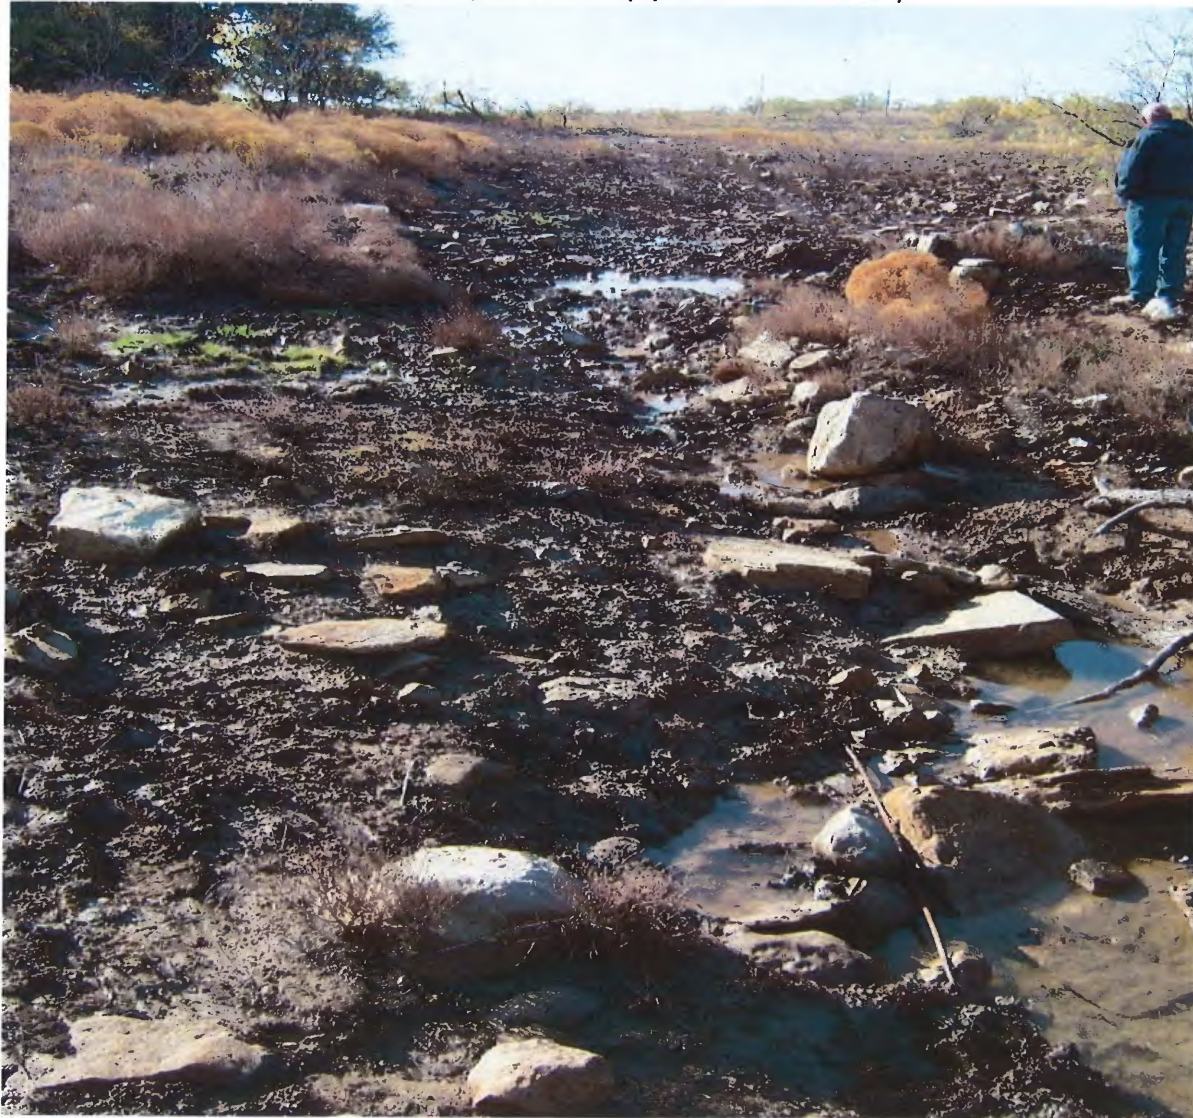
Creed Operating Facility Co., LLC Photo 10

Photo #10. Facing south east from point of entry to Need Creek. Observed a tributary upstream to the pond containing produce water (salt water). TSS concentration was 6500 ppm.

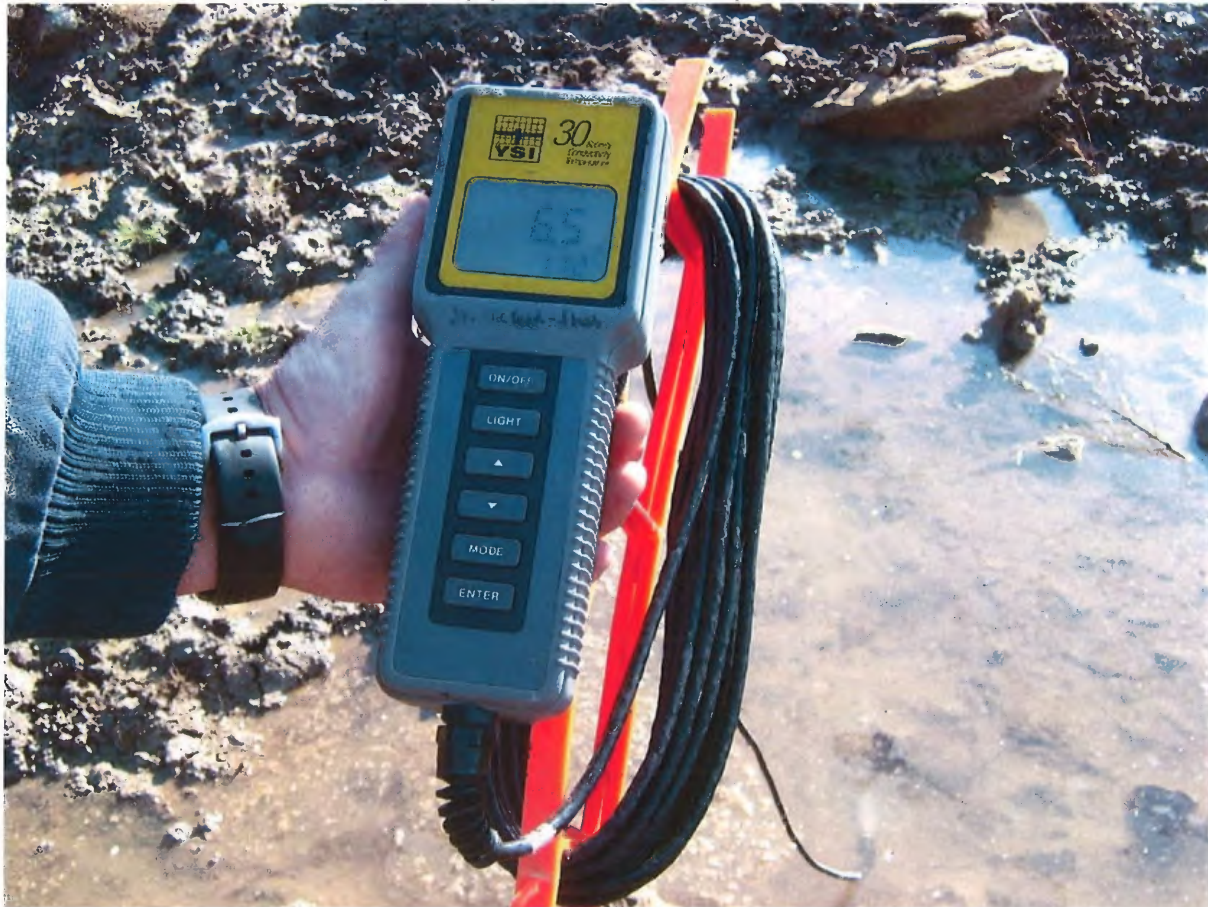
Creed Operating Facility Co., LLC Photo 11

Photo #11. Facing south east from point of entry to Need Creek. TSS measurement of standing fluids was 6500 ppm TSS. Did not observe microorganism in pool of water. Pool in tributary discharge directly in pond and eventually in Ned Creek.

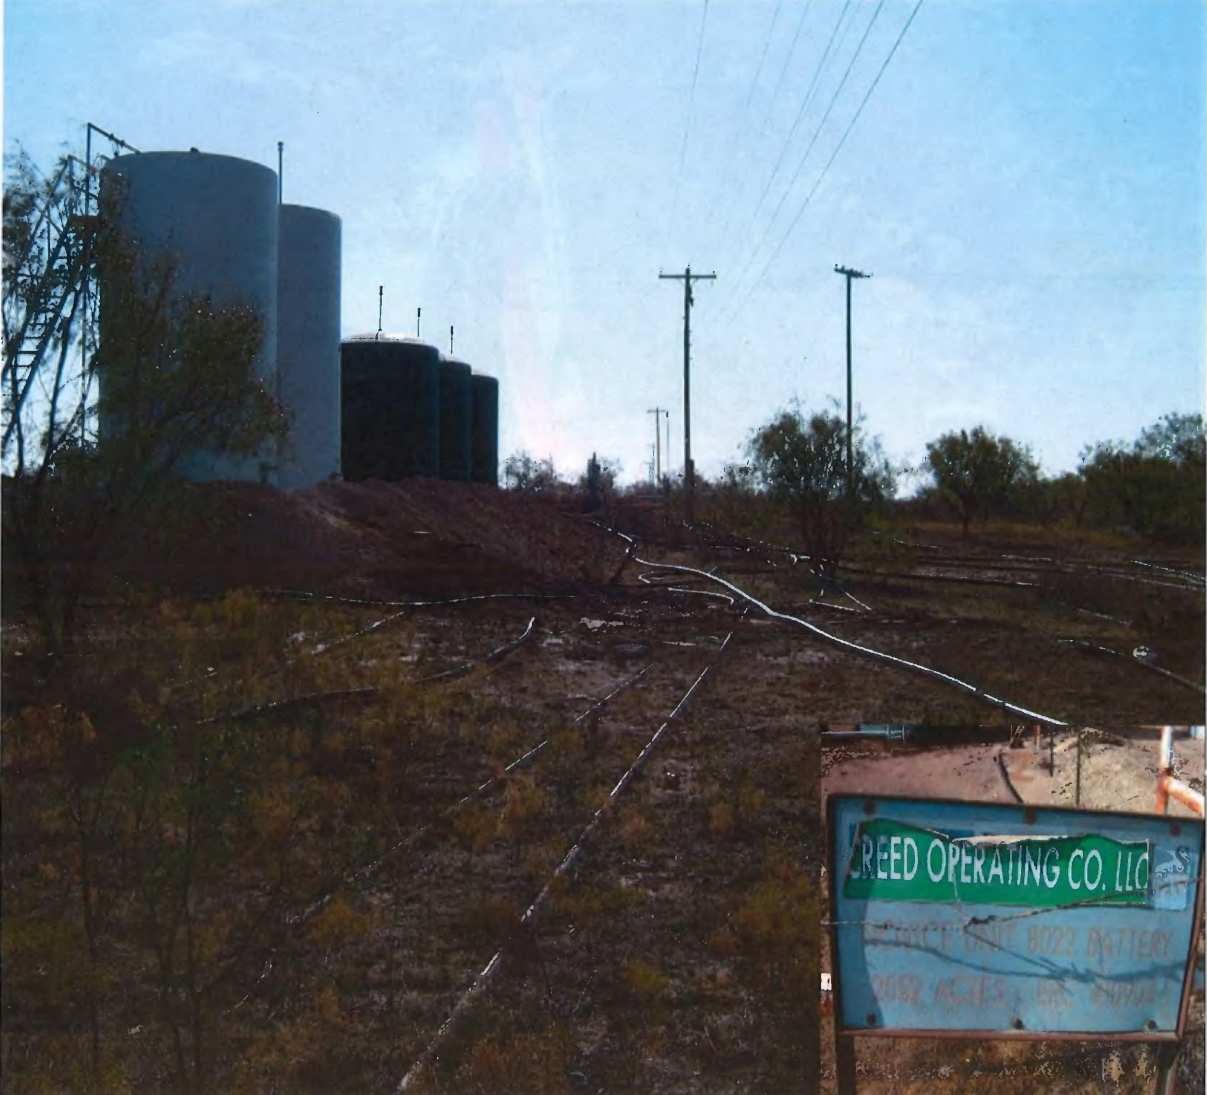
Creed Operating Facility Co., LLC Photo 12

Photo #12. Facing south east from point of entry to Need Creek. Observed storage tanks containing fluids (oil and brine). Pipes placed improperly on the ground. Berms are inappropriate to contain overflow of fluids in case of emergency or technical failure.

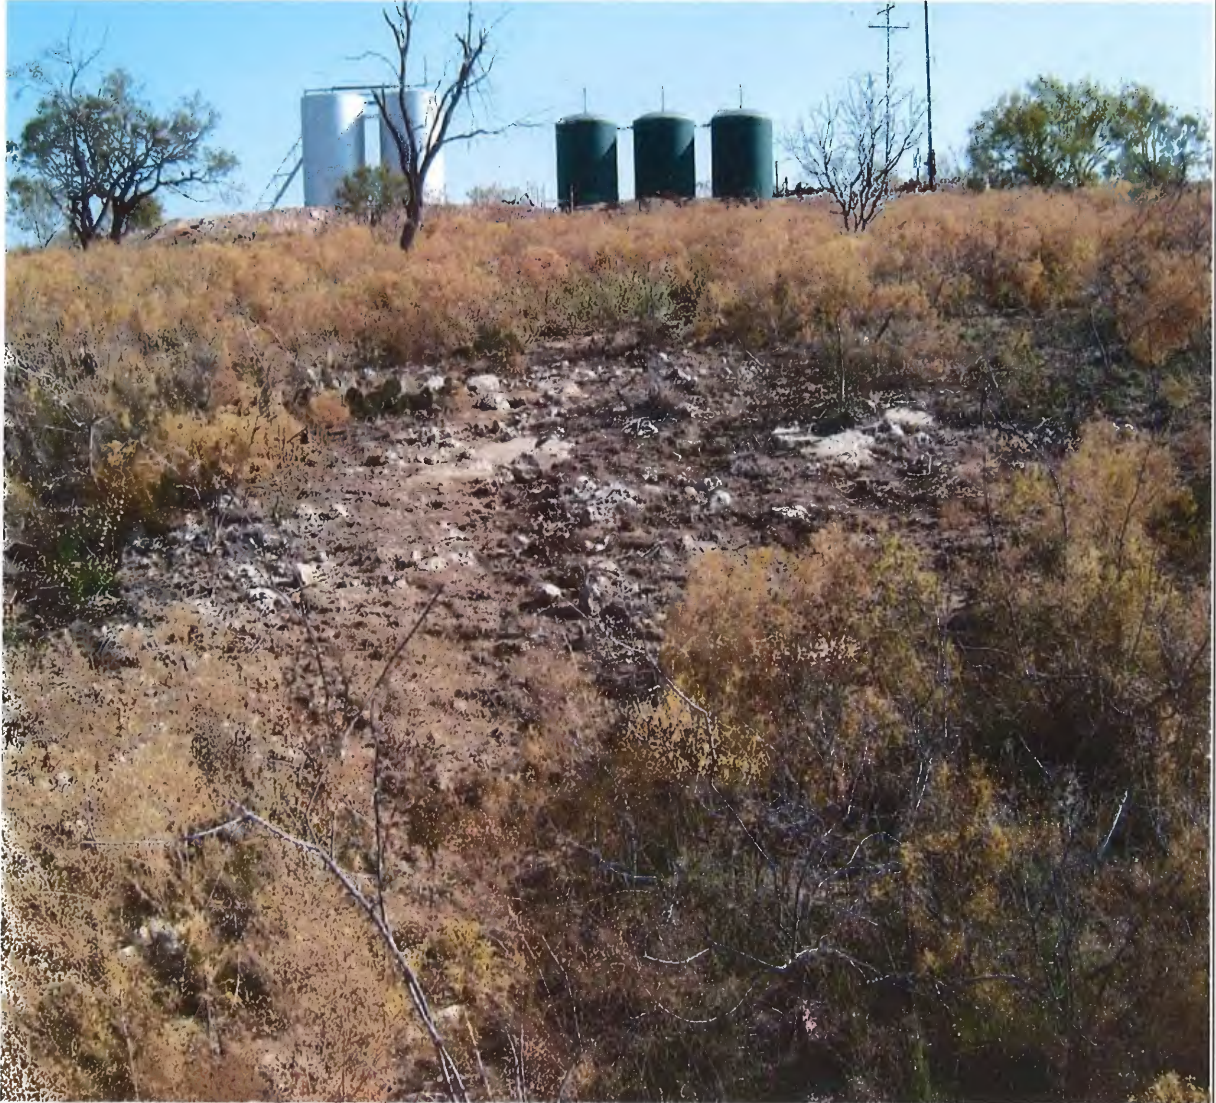
Creed Operating Facility Co., LLC Photo 13

Photo #13. Facing south east from point of entry to Need Creek. Observed a discharge flow path going directly into the tributary, discharging in pond and eventually in Ned Creek. Observed dead vegetation and small formations of salt crystals.

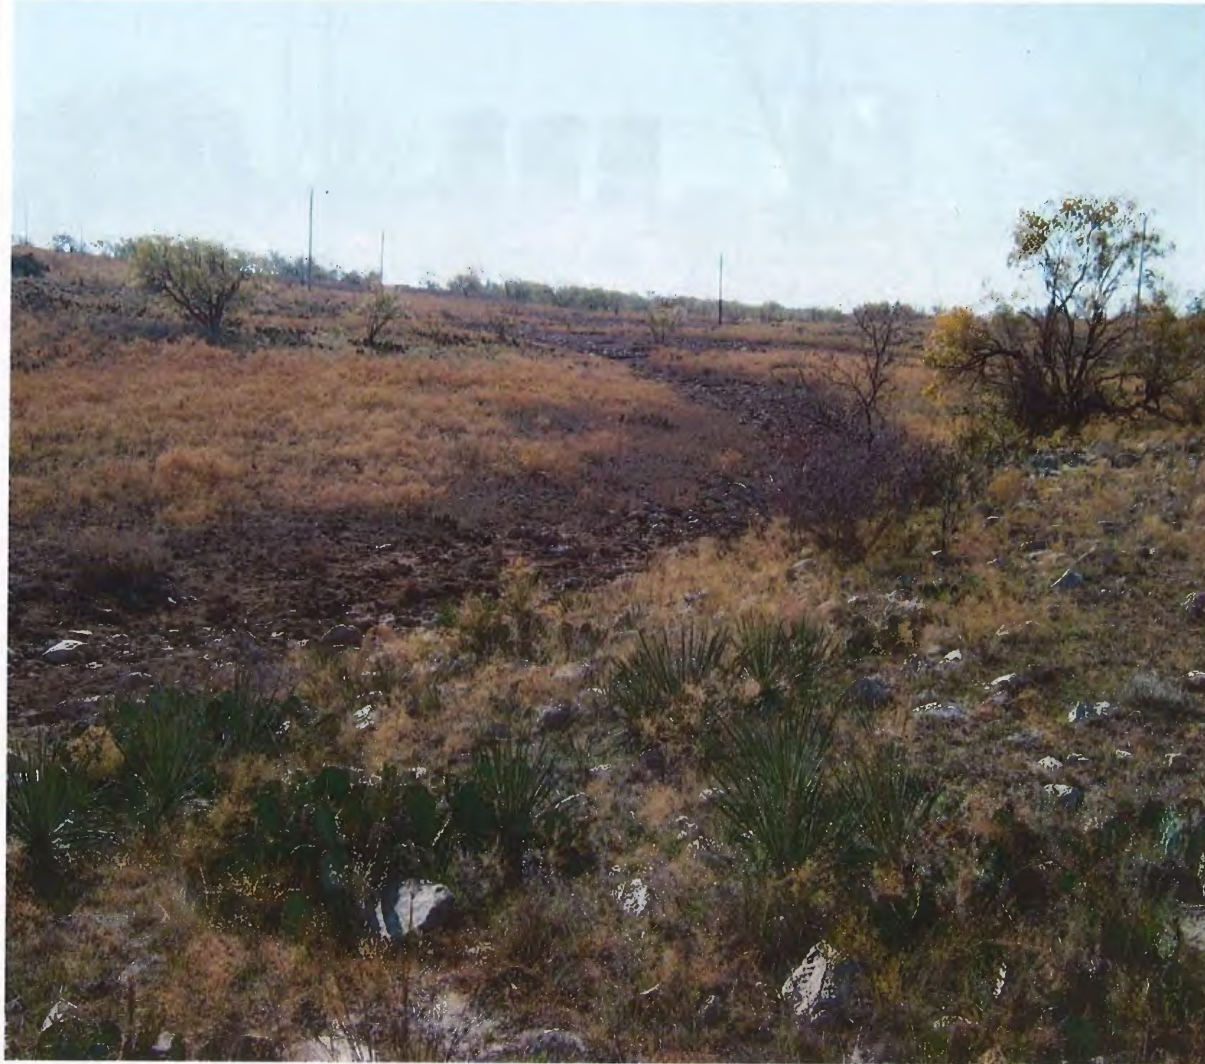
Creed Operating Facility Co., LLC Photo 14

Photo #14. Facing south east from point of entry to Need Creek. Observed a discharge flow path went directly into the tributary (TSS 6500 ppm) , discharged in pond (TSS 5700) and eventually in Ned Creek (TSS 1100).

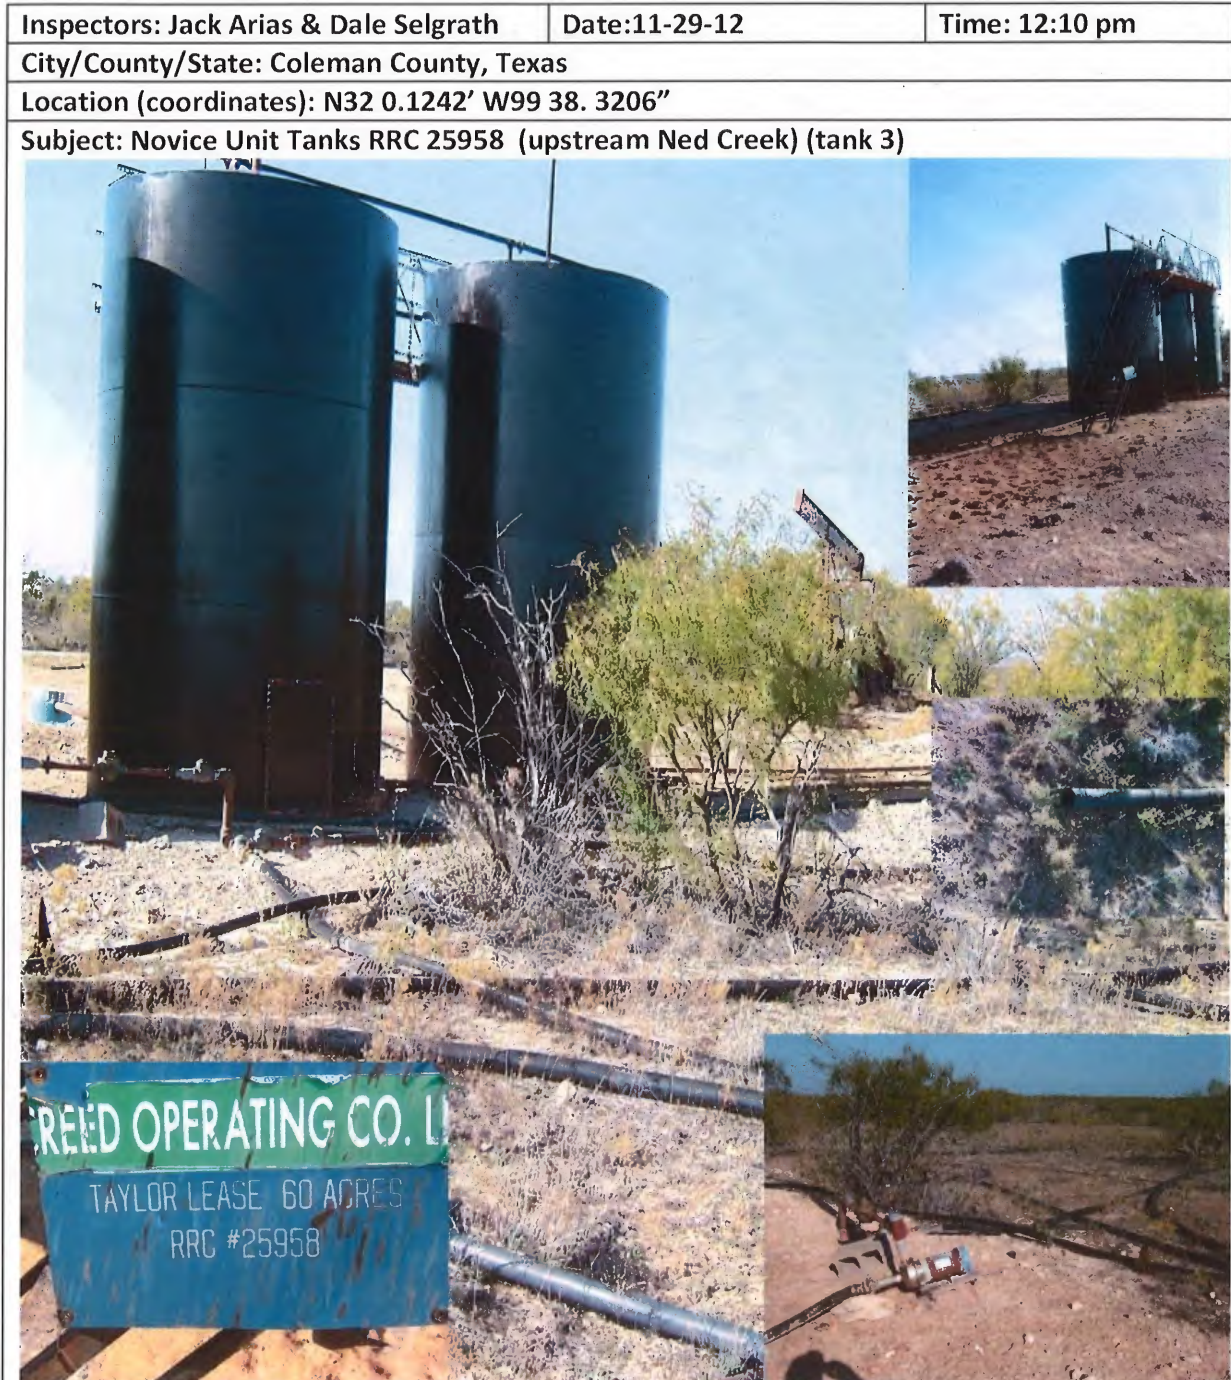
Creed Operating Facility Co., LLC Photo 15

Photo #15. Facing south east from point of entry to Need Creek. Observed a discharge flow paths around tanks. Pipes placed improperly, there are not berms around tanks, and several pipes were open directly discharging in open areas and tributary.

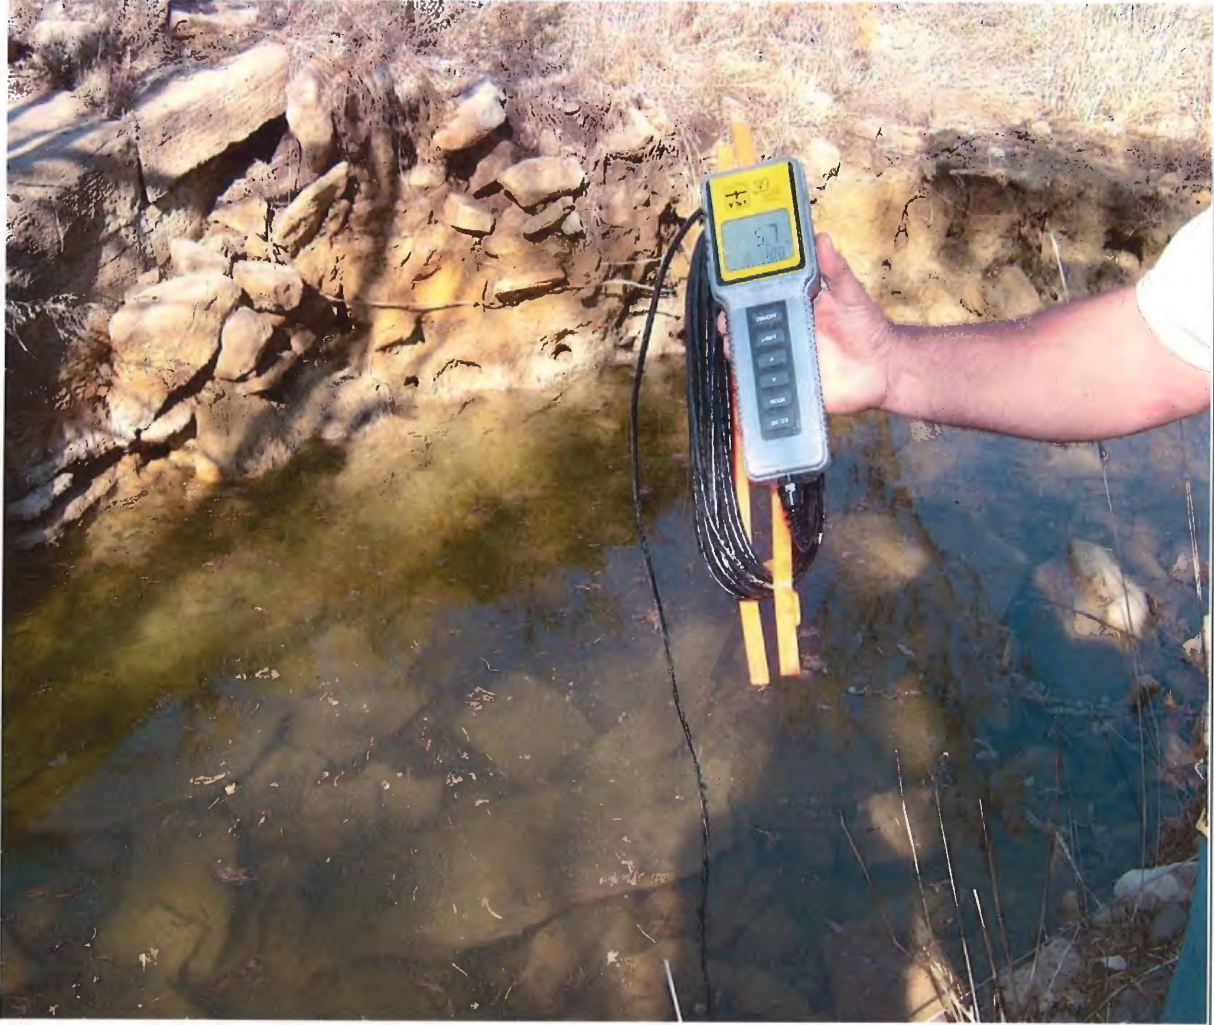
Creed Operating Facility Co., LLC Photo 16

<p>Photo #16. Facing south east from point of entry to Need Creek and east from train rail. TSS measurement of standing fluids was 5700 ppm TSS. Did not observe microorganism in pool of water. Water in tributary discharge directly into Ned Creek.</p>
